page 1 of 6 Test No.: 4901

Test Intention:					
In test 4901 we want to investigate and compare the lifespan of our CF211 on the short way.					
Client:					
Name: Christian Mittelstedt	Team: chainflex	®	Date:	24.02.2014	
Order-Info:					
Customer / No.: igus® GmbH, Spicher Str.1a, 51147 Köln					
Series / No: CF211		Installation type: horizontal, short way			
Customer test: Yes ☐ No ☐		Development test:	Yes ⊠ No		
Technical data		Target & Examination

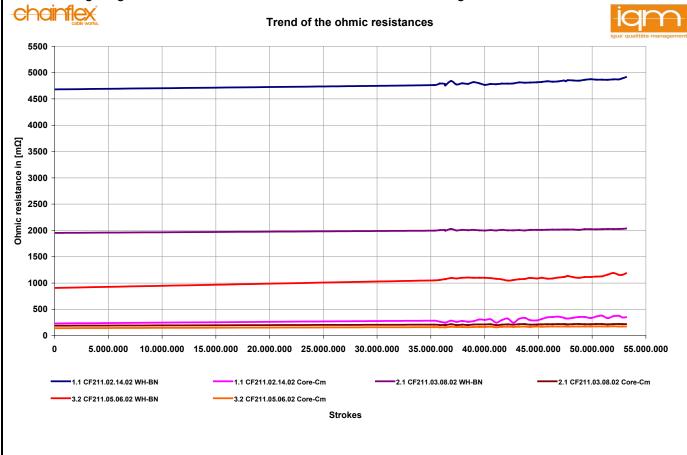
At the 22.03.2016 after 53.152.584 strokes we demounted the cables, because we want to finalize the test.

The following diagram shows the trend of the ohmic resistances during the test:

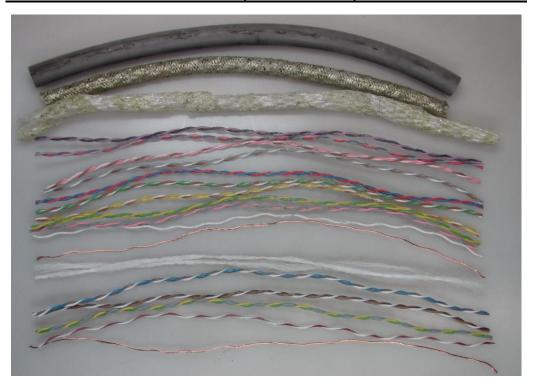
The condition of the cable no. 1.1 (CF211.02.14.02) after 53.152.584 strokes

Strokes	53.152.584
Condition outer jacket	O.K.
Condition overall shielding	Broken single wires
Condition banding	Ruptured
Condition centre element	O.K.
Condition core insulation	O.K.
Condition conductor	O.K.
- centre layer -	
Condition core insulation	O.K.
Condition conductor	O.K.

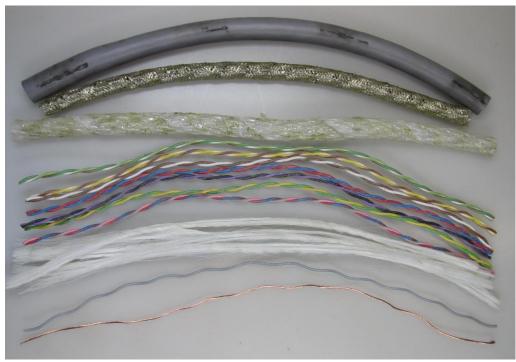
The condition of the cable no. 2.1 (CF211.03.08.02) after 53.152.584 strokes

Strokes	53.152.584
Condition outer jacket	O.K.
Condition overall shielding	Broken single wires
Condition banding	Ruptured
Condition centre element	O.K.
Condition core insulation	O.K.
Condition conductor	O.K.

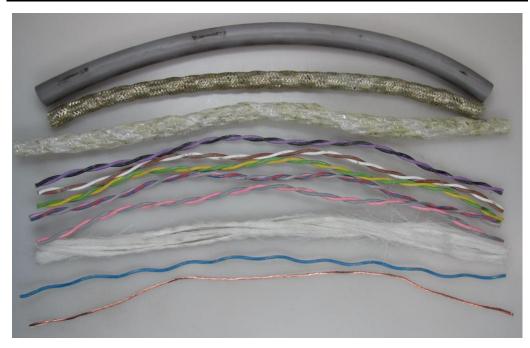
The condition of the cable no. 3.1 (CF211.05.06.02) after 53.152.584 strokes

Strokes	53.152.584
Condition outer jacket	O.K.
Condition overall shielding	Broken single wires
Condition banding	Ruptured
Condition centre element	Ruptured
Condition core insulation	O.K.
Condition conductor	O.K.
